NOVEMBER 2021

HANA + Walkable Arlington Walk Audit

Arlington, Texas

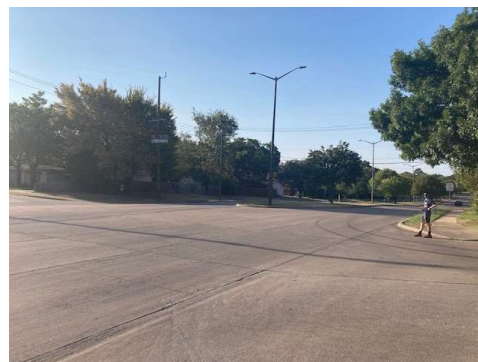
The greatest issue encountered in the S. Center Street route was the lack of intersection safety. During the course of the audit, pedestrians and cyclists were observed crossing six lanes of traffic to get to the strip mall on the

east side of S. Center Street (see Figure 2). Audit participant and long-time resident Jim Gayda observed that during weekday morning and evening traffic it would be very difficult if not impossible for pedestrians and cyclists to cross over S. Center street. Although a median can be found on S. Center Street, it does not serve as a pedestrian/bicycle walkway/island. The closest signalized crossing is approximately 700 feet away. The audit team observed unsafe driver behavior on S. Center Street. Drivers did not respect stop signs and did not look for pedestrians when leaving neighborhood streets and entering on S. Center street. Gayda reported concerns of speeding and reckless driver behavior along S. Center during weekday afternoons. With the exception of some cyclists riding on the street to make way for pedestrians present on sidewalks, cyclists of different ages (school age and adults) were observed riding on the sidewalks. Bicycle infrastructure was rated as very bad as there were no safe alternatives from sidewalks. Broken and cracked sidewalks, interrupted by poles and wires and low hanging trees were found on both sides of S. Center street (see Appendix, Figure 3). Some sidewalk gaps were up to two inches tall, making it a trip hazard and going against ADA sidewalk requirements (See Appendix, Figure 4). Litter was found scattered throughout the entire audit area along with overgrown grasses and dead plants, disrupting the textured markings on crossings (see Appendix, Figure 5). The audit team discussed safety concerns of wheelchair users and slower walkers including children and elderly (which were observed during the audit) using the sidewalks and crossings on S. Center Street.

Figure 2. Crossing six lanes on S. Center Street (each lane is 12 ft wide)

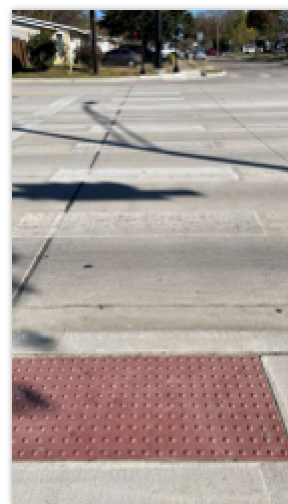
crosswalk from Lovers Ln to the school sidewalk was barely visible on the street, even though it was just painted a few months ago. Crossing guards are typically present to assist students before and after school. Another issue at the school property is a pedestrian crossing light, just south of the traffic signal at Lovers and on the south side of the school's entrance driveway. The crossing signal is of little value to students at the school who never have to cross that driveway at Collins due to school sidewalks on either side of the driveway. For pedestrians on the west side of Collins, the signal was timed through two cycles. The signal was red for 6:35:00 then changed for 15 seconds to permit crossing. Biggs Terr and Meadow Ln also received recent street rebuilds so the street and sidewalks there were in excellent condition. There are few trees providing shade along Biggs Terr but overall, walking was comfortable. Meadow Ln had two major problems. First, when the street was rebuilt the existing sidewalks were replaced. Apparently there was never a sidewalk on either side of the street along the Meadow Lane Baptist Church property and no new sidewalk was installed during the street rebuild. There is a gentle S-curve in the street along church property (See figure 4) which makes it difficult to see down the street and for drivers traveling in both directions to see any bicycles or pedestrians on the street in that area. The church is directly behind Blanton Elementary property and there is a rear entrance to the school from the church parking lot and the second major problem in this area. A sidewalk from Meadow goes uphill to an opening in the fence and continues all the way to the school buildings; however, approximately 12 ft of sidewalk is missing before the entrance and the ground there has eroded considerably leaving only a narrow dirt path with steep drop off to the adjacent parking lot before the entrance to the

Figure 8: Lovers Ln to Blanton sidewalk faded crosswalk

- Blanton Elementary
 - Clearly defined crosswalk on Collins at Lovers Ln
 - Adjust timing of the pedestrian crossing signal at the Blanton entrance driveway (or remove it altogether as it offers no value to pedestrians in this area.)

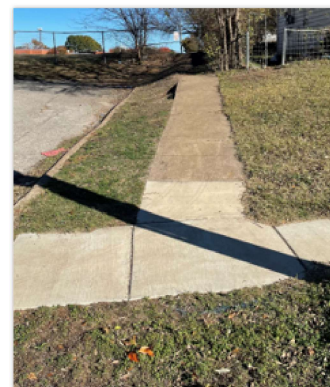
Figure 9: Sidewalk abruptly ends on Meadow Ln

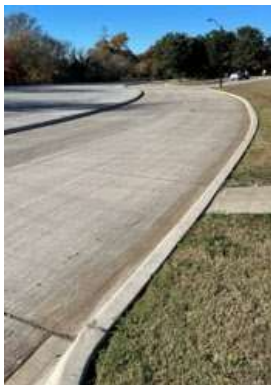
Figure 10: S Shape along Meadow Ln

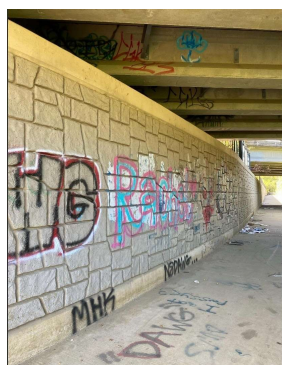
Figure 22. Graffiti underneath the S. Center Street bridge.

Vacant parking lots to nearby churches and schools were large, but sparsely populated. This is bad, because the portion of the parking lots that people are not using could be used for other buildings, houses, or nature. Another problem was trash and graffiti. Trash like soda cans, chip bags, balled-up paper, and more were littered about, and homeless camps had been left behind with no signs of the homeless still living there. Graffiti sat underneath the bridge on S. Center Street, some saying vulgar curse words, and other being general eye sores to look at. All in all, these issues made the walking experience generally uncomfortable.

- Closing sidewalk gaps, making sidewalks ADA friendly
- Julia Burgen Park
 - Clean up landscaping throughout route
 - Remove graffiti within Julia Burgen Park, under the bridge on S. Center Street

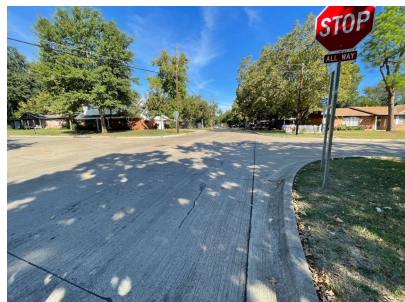
Figure 28. Lynda/Brookview intersection. This intersection can use traffic calming measures such as a roundabout.

the intersections of Inwood/Brookview and Lynda/Brookview, even though the stop signs were present, they were not highly visible so drivers sometimes skipped the stop sign and kept going. Even more concerning at Lynda/Brookview is that there are no sidewalk connections to the intersection and no other protective infrastructure despite the fact that the intersection is a bus stop for school children. The rest of the walk audit continued pleasantly on Lynda, but there were several lots at the intersection of Cooper Street that were empty which could benefit from infill developments/upzoning.

- Paint a crosswalk at Robin Ln., Park Row
- Inwood
 - Car ports: other methods of permeable paving (long term)
 - Interim strategies of bulb-outs and traffic circles to calm traffic

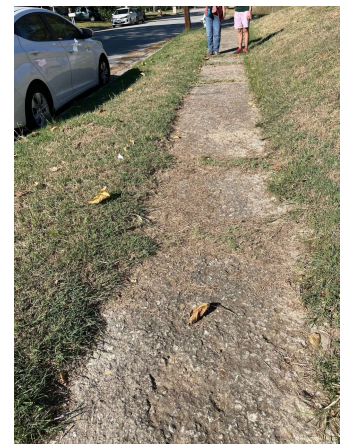
Figure 29. The general state of sidewalks in the area.

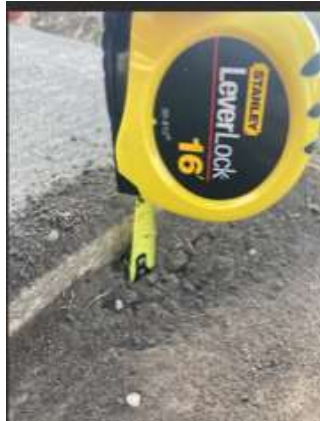
Figure 4. Trip hazard: 2 inch sidewalk crack

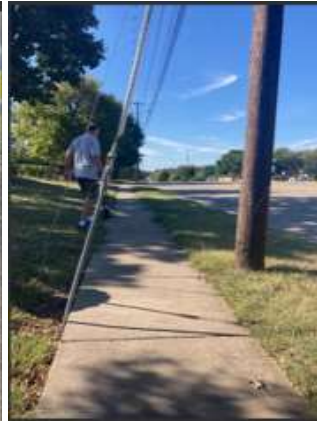
Figure 5. Poles and cables blocking pedestrians and cyclists on sidewalks

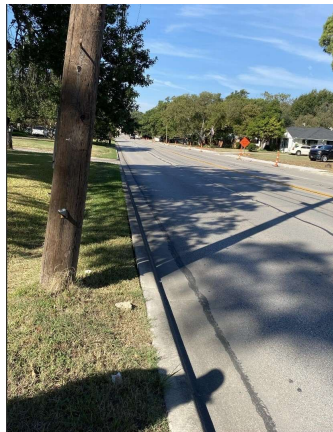
Figure 24: No sidewalk and no buffer between grass and street

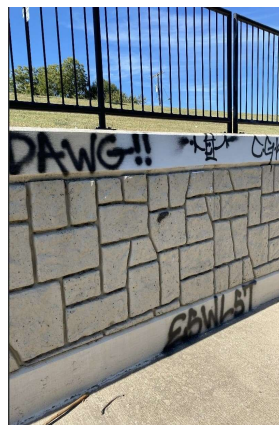
Figure 25: Graffiti at Julia Burgen Park, near the underneath of the S. Center Street bridge.

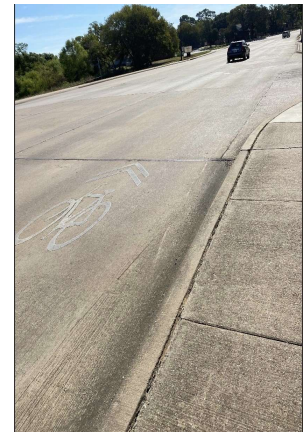
Figure 26: sharrow on S. Center Street, faded paint, unsafe infrastructure for cyclists

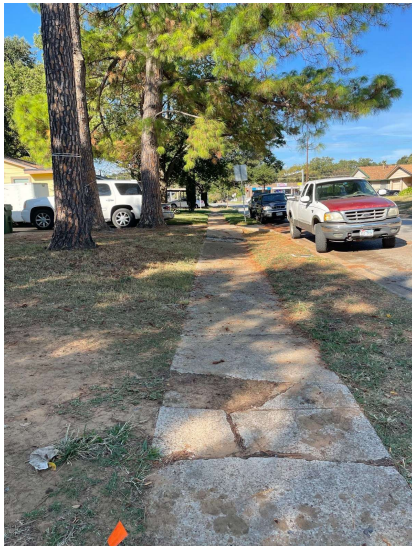
Figure 30: A poorly maintained sidewalk on Inwood Street near Cooper Street intersection

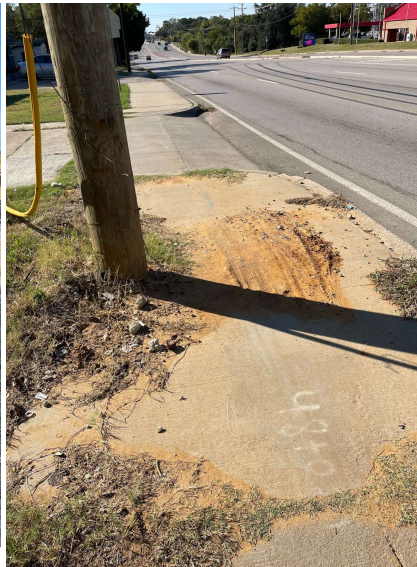
challenge: the team did not feel safe walking by vehicles despite the slightly wider sidewalks (6 ft as opposed to the usual 4 ft in the area) because the vehicles were driving at an uncomfortable speed for pedestrians to walk next to. The sidewalks on Lovers Lane were okay but midway through the street, the sidewalks stopped and we were forced to walk on the street. Despite the lack of sidewalks, the streets themselves (Lovers Lane and Brookview) are relatively wide so vehicles traversing the route would be driving relatively fast, which was the observation we took note of. At

Figure 31: Cooper Street west sidewalk

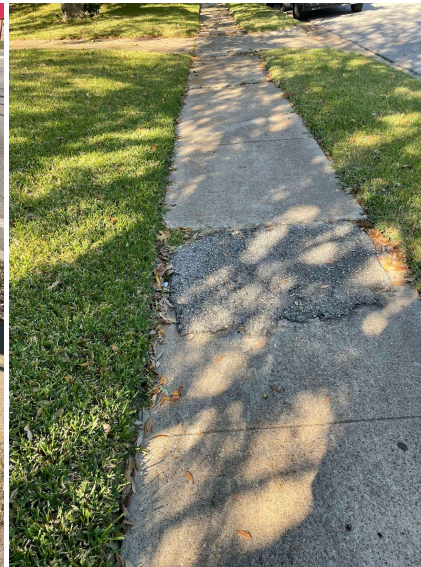
Figure 32: The general state of sidewalks in the area
