# The University of Texas at Arlington Extensive Green Roof

By David Hopman, ASLA

The University of Texas at Arlington School of Architecture

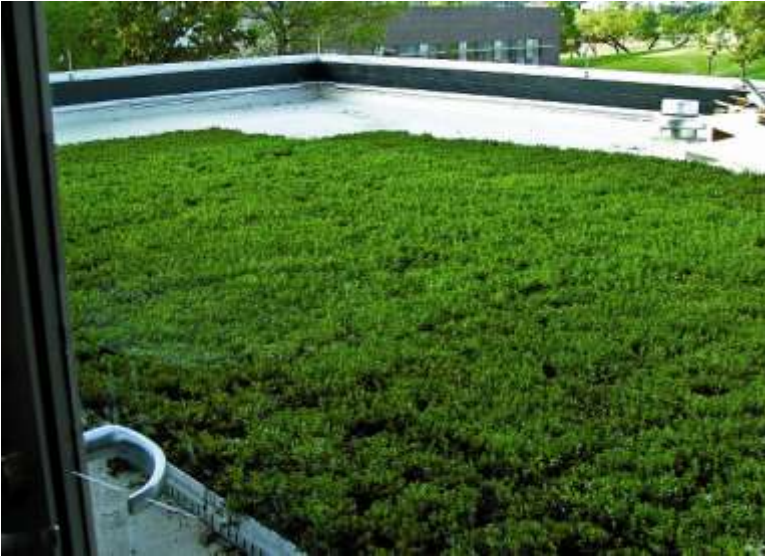
Figure 3: Sedum Roof at Northlake College in Irving, Texas soon after installation. The Sedum was pre-grown using the “Live Roof” system.

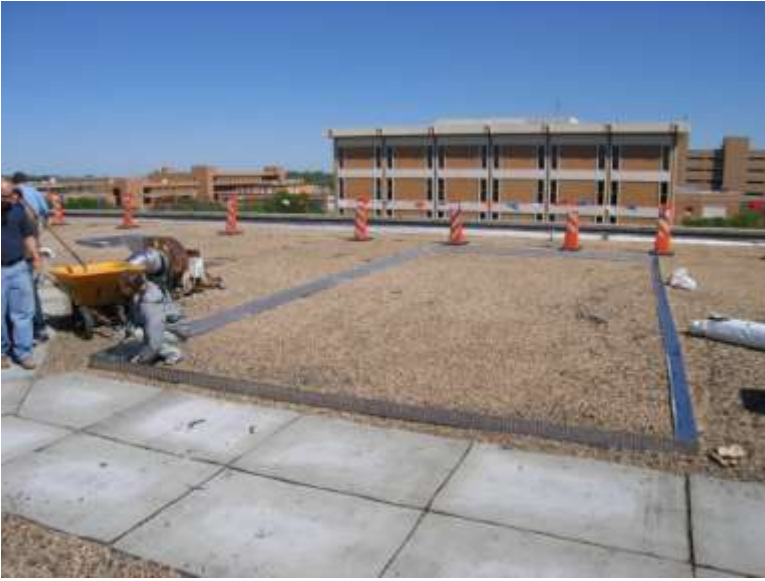
**Figure 4: Garden Roof frame provided by Hydrotech**

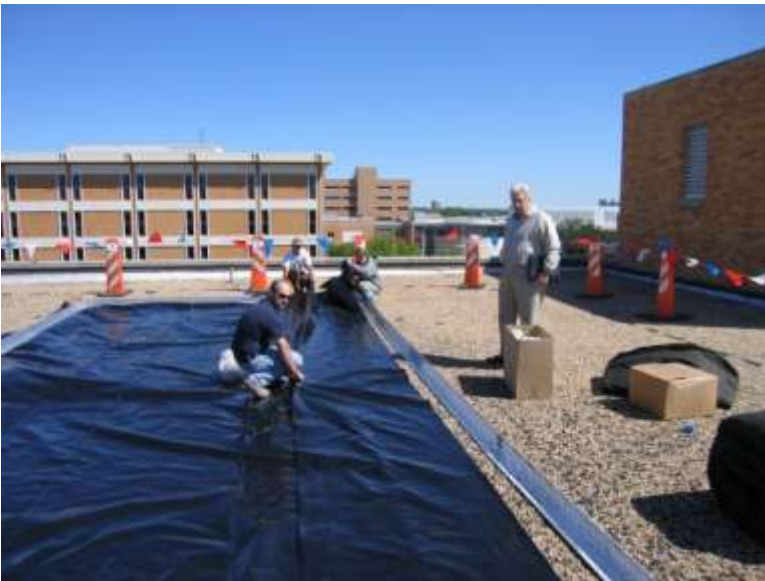
**Figure 5: Installation of root barriers as Robert Nichol, of American Hydrotech, looks on**

Two layers of plastic root barrier were used to assure that no roots make their way through to the existing ballast roof. The moisture mat placed above the root barrier is a thick layer of felt that is designed to capture water and slowly release it as water vapor that precipitates off of the filter fabric and back into the Floradrain. The Floradrain was placed with the holes on the highest points and with expanded shale placed in the small egg-cupped shaped valleys. This was on the advice of Hydrotech for the extreme environment of North Texas. The next layer above the Floradrain was filter fabric, followed by 4 inches of growing media. This media is a proprietary formulation of sand, expanded shale, and a small amount of compost to get the plants started. It is produced locally and arrives in 1500 lb grow bags. It should be noted that there is considerable amount of settling of the soil and an excess of 10 to 15 percent above the calculated quantity or more may be required to achieve the desired depth. More soil was added to this roof after installation to keep the level closer to 4 inches. The saturated weight for the entire system is calculated by American Hydrotech at 30 lbs/sf. or less. A coconut fiber 'moisture mat' was added over the media a few weeks after installation to prevent fine particles (sand and compost) from blowing away in the strong winds on the roof. The mat was removed in July when the winds died down in order not to impede plants from spreading.

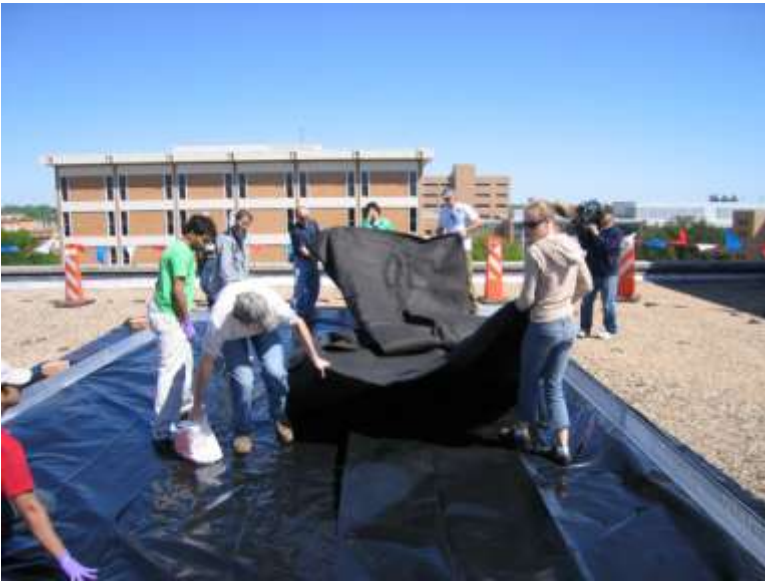
**Figure 6: Students and other volunteers install moisture mat**

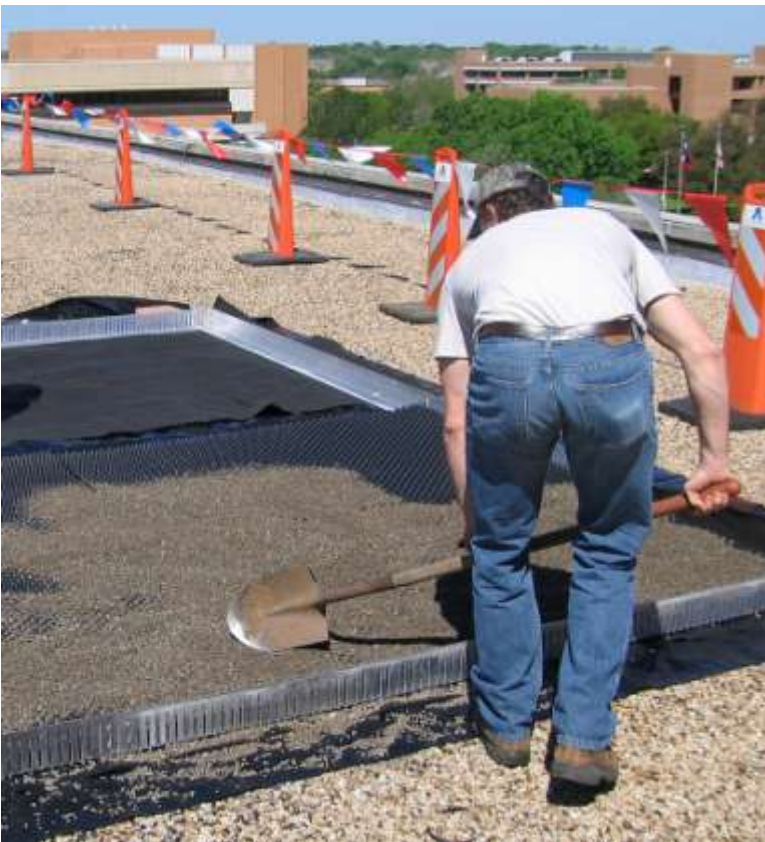
**Figure 7: MLA student Joey Ball places expanded shale on top of the Floradrain**

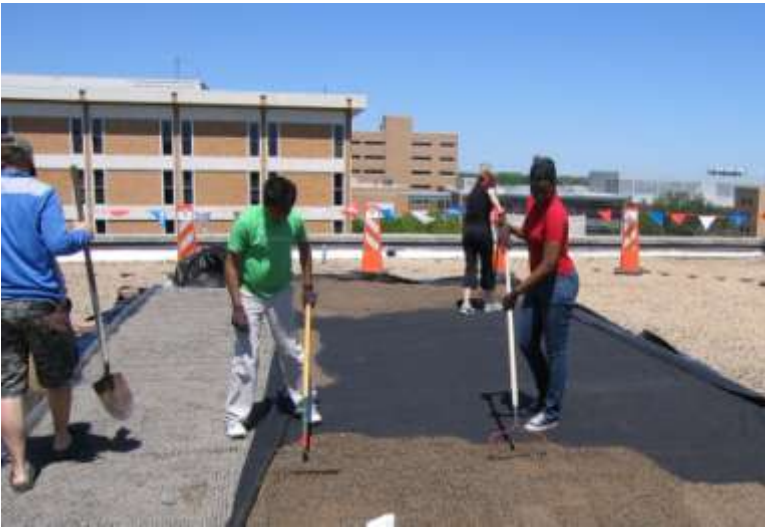
**Figure 8: Growing media is placed over filter fabric**

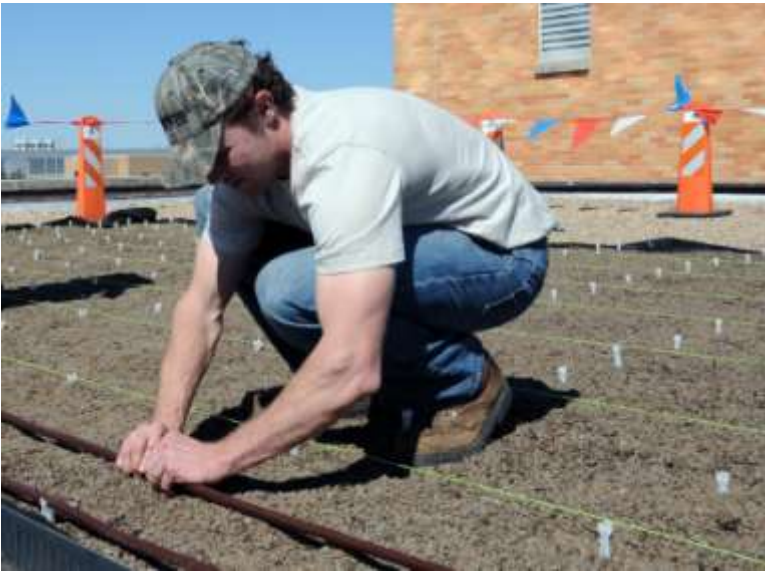
**Figure 9: Netafim Drip Irrigation lines are snapped into 3-1/2 inch plastic rebar risers**

The irrigation system installed on the Hydrotech side was a standard Netafim Drip System. There are headers on the two short sides of the rectangle. Techline CV12 pressure compensating dripperline is run between the headers and clipped into 3-1/2 inch plastic concrete rebar risers. The emitters are the slowest available releasing .25 gallons per hour. In the hottest and driest summer months, the system is run twice per week for 50 minutes at a time. This results in water usage of 212 gallons per week for the 500 sf. Netafim side. This rate was arrived at by allowing the media to dry out to the point that some of the plants were starting to wilt such as Rudbeckia, and Liatris. The system was then run until it started running off. The roof is irrigated about 4 months of the year on a regular basis and occasionally in fall and spring during extended dry periods. As an experiment, ½ of the roof was left without

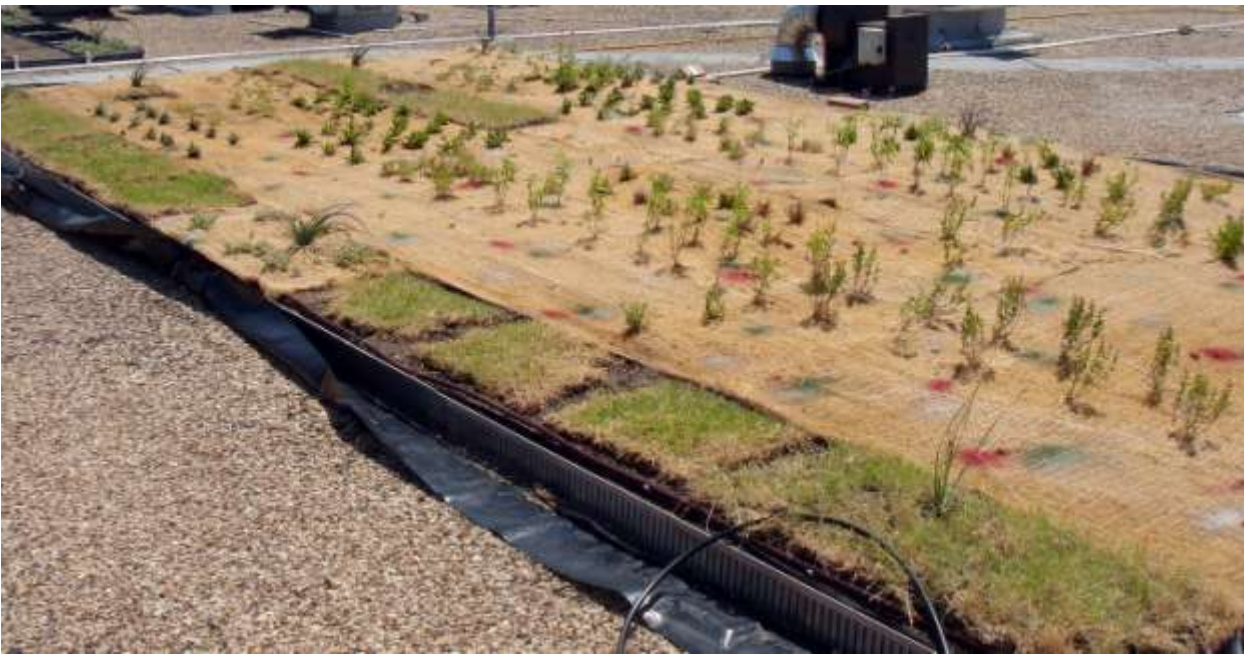
**Figure 11: A coconut fiber 'moisture mat' was installed for two months on the Hydrotech side to keep fine media particles from blowing away in hot, dry, windy, conditions.**

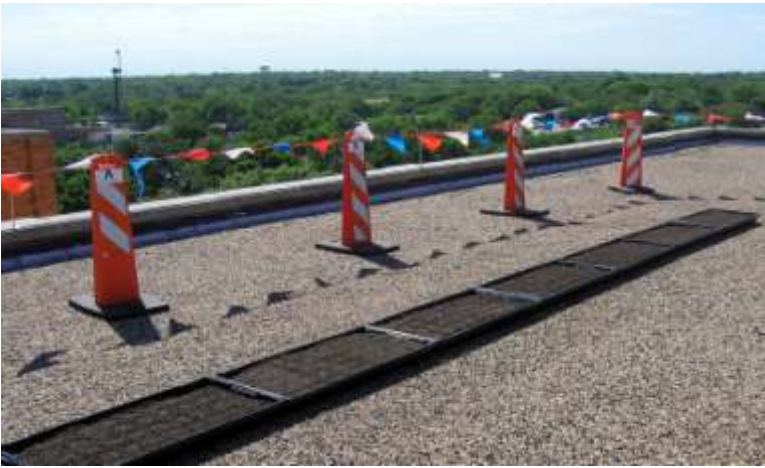
**Figure 13: First row of pre-filled trays are placed on roof**

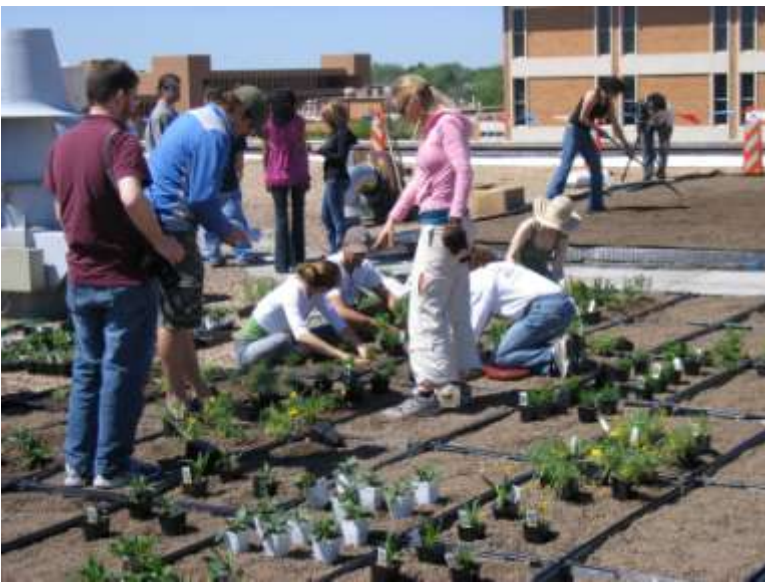
**Figure 14: installing plants in the GreenGrid System**

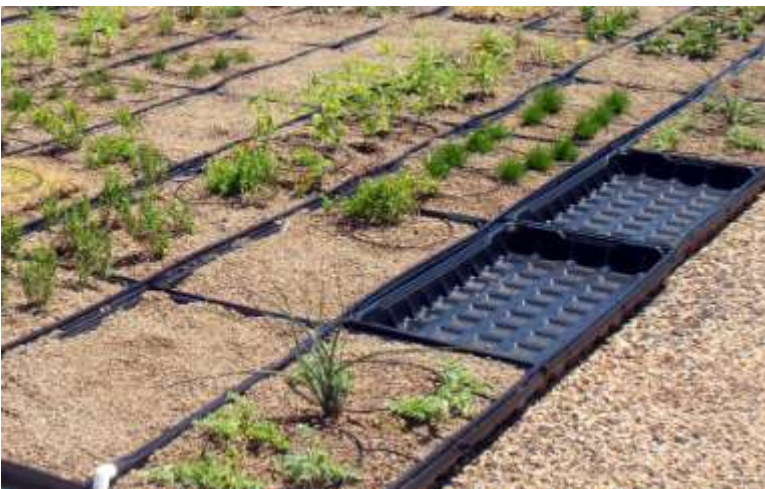
**Figure 15: GreenGrid Side—partially planted out—three weeks after installation**

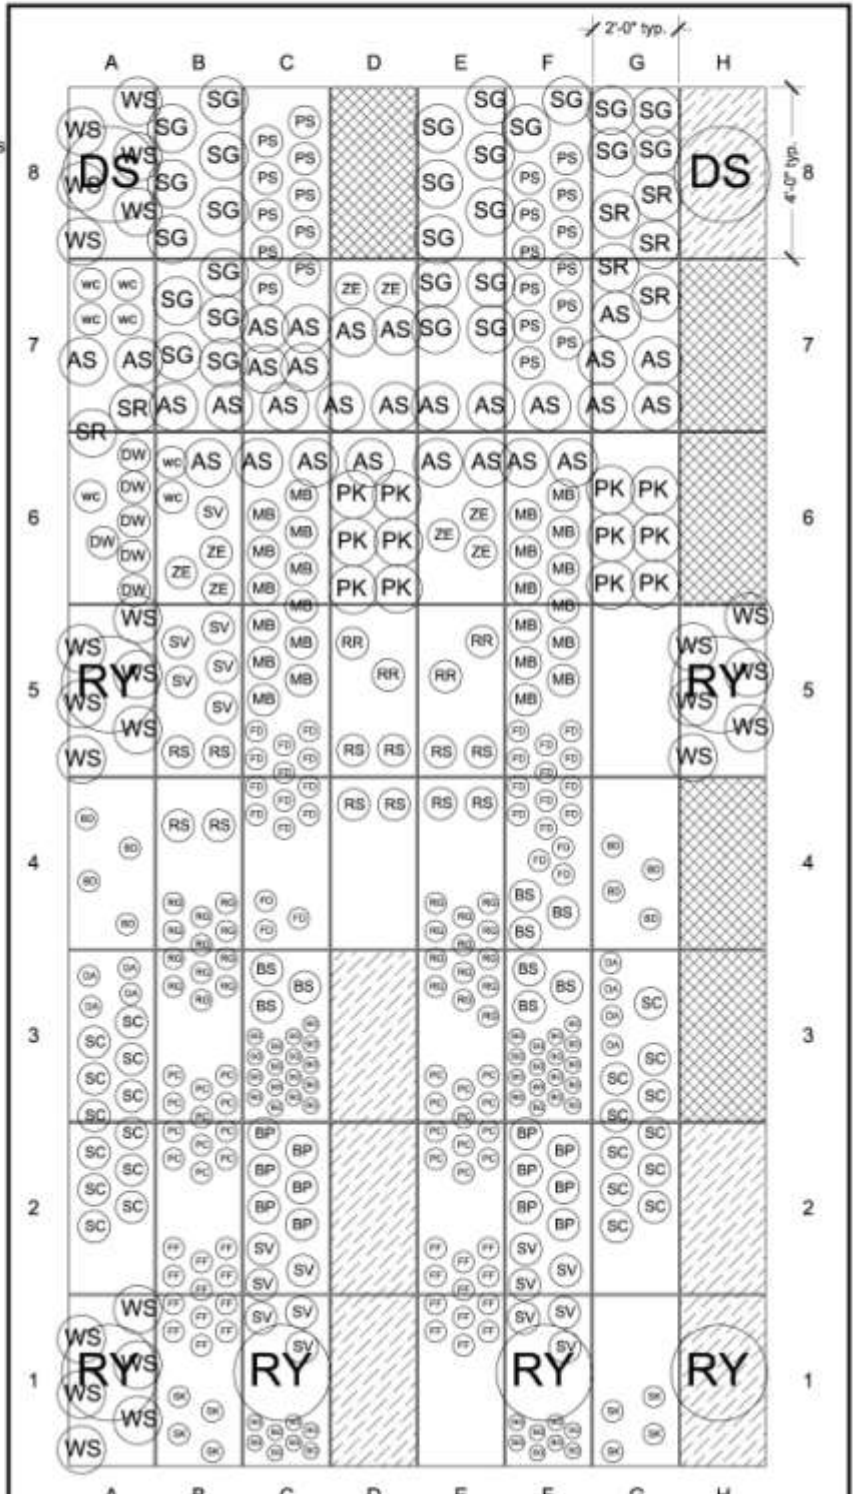
# UTA LIFE SCIENCES BUILDING EXTENSIVE GREEN ROOF

HYDROTECH SIDE
